PIPELINE PERFORMANCE EXPERIENCES DURING SEISMIC EVENTS IN NEW ZEALAND, 1987 TO 2015

Frank W. O'Callaghan, Iplex Pipelines NZ Ltd, New Zealand

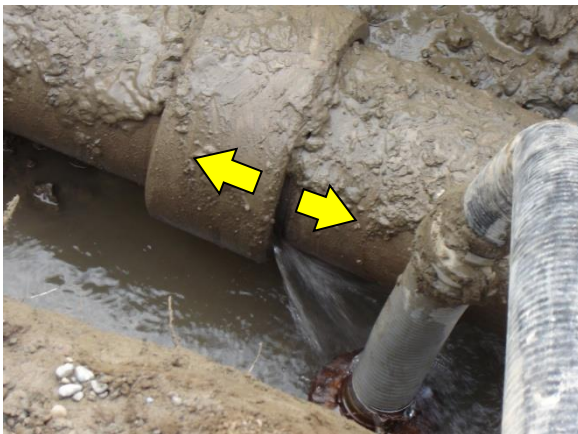
Figure III - Tension effects in AC pipe joint, Sewell Street Kaiapoi, axially aligned with the Darfield epicenter, 2010

Axial compressive/expansive movements within pipe joints in liquefied ground with no lateral spread were commonly only up to about 100 or 150 mm. Those pipe sockets able to accommodate the movement remained connected, but at points of pipe breakage in compression or joint separation, the liquefied ground rapidly invaded the pipe bore during the earthquake, then compacted and solidified as the passage of seismic energy ceased. In eastern Christchurch, difficulties in removing the solidified silt, together with widespread changes in ground levels, and pipe grades, directly influenced whether pipes were repaired or abandoned, and if replaced later, what replacement methodology was possible. For example, where the original pipeline grade had been changed or reversed, gravity sewer street reticulation mains could not be replaced by low impact trenchless methods such as bursting or lining; open cut was needed to restore the grade. In contrast, slumping and lateral spreading effects in liquefied ground, at Edgecumbe, Christchurch and Kaiapoi induced axial, shear and lateral pipe movements, of up to several metres. These movements occurred rapidly during the earthquake, over about 18 to 20 seconds, and more slowly from aftershocks during following days, with acute disruption to pipe assets and joints to structures, regardless of pipe

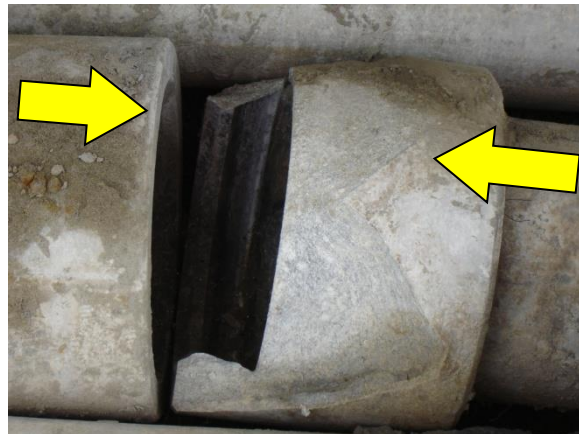
Figure IV - Compression effects in AC pipe joint, Sewell Street, Kaiapoi, axially aligned with the Darfield epicenter, 2010

Pipe/joint type	Compressive Phase movement in Liquefiable ground	Location/ Seismic Event
AC pressure and sewer	Localised 45 deg compression fracture of rubber ring coupling joints and crushed pipe spigots. (Figure IV and Figure VI)	Edgcumbe Christchurch Kaiapoi
EW sewer	Disintegration of whole pipe into random shards, or localised brittle ring fracture of mortar sealed bell and spigot joints.	Edgcumbe Christchurch Kaiapoi
VC sewer	Disintegration of whole pipe into random shards localised brittle fracture of rubber ring bell and spigot joints.	Christchurch Kaiapoi
RRRC sewer	Localised “telescoped” brittle fracture of rubber ring bell and spigot joints.	Christchurch Kaiapoi
PVC pressure and sewer	Localised ductile pipe barrel section folding/buckling. Localised “telescoping” of joints (Figure X), (caused by the pipe spigot being driven through the socket bell, and beyond into the pipe bore itself). Ductile fracture of sewer service lateral junctions, ductile tearing at socket joints,	Christchurch Kaiapoi

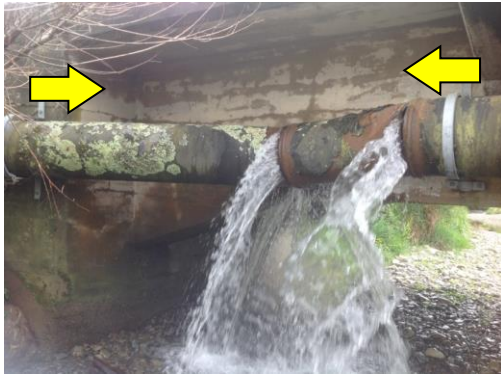
Figure V - Compression distortion and separation of RRJ joints in CLS watermain, 2014

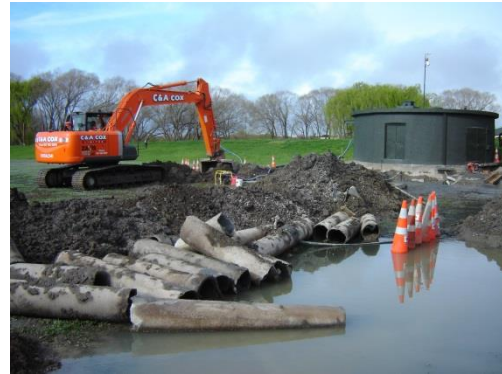
Figure VI – Compression fractures of pipe ends and joints in AC sewer rising main, Charles St, Kaiapoi, axially aligned with the Darfield epicentre, 2010 (Replaced with Biaxially Orientated PVC (PVC-O)

Biaxially orientated PVC (PVC-O) pressure pipe installed in 2010 to replace the destroyed AC sewer rising main at Charles St in Kaiapoi, (Figure VI) remained undamaged, during the Christchurch and Lyttelton events of 2011 and all subsequent aftershocks.

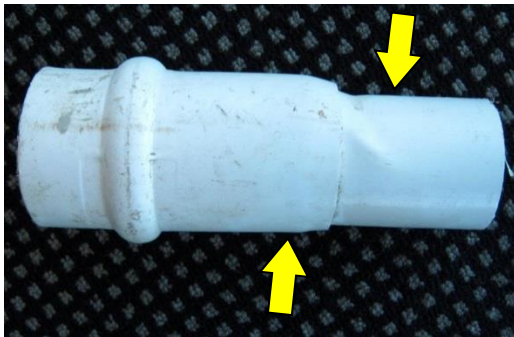
In the Waimakariri River flood plain extending under Christchurch City and Kaiapoi, sharply defined liquefiable ground zones exist, intermixed with non-liquefiable ground zones, at varying depths. The intensity of pipe damage observed alternated from often extensive, or total, in the liquefaction or lateral spread zones, to examples of minimal or no damage observed in the same pipes in adjacent non-liquefaction areas. A close association between approximate axial alignment of the pipe with the earthquake epicentre and type of pipe response was seen, in pipes of AC, CLS, and PVC-U at Edgecumbe, Carterton (Eketahuna event), Kaiapoi, Pines Beach / Kairaki Beach (Darfield event), and Christchurch. Resulting localised movements at pipe joints suggested the passage of rapidly alternating axial compressive or expansive movements in the liquefied ground. Pipes in streets aligned with the epicenter in liquefiable ground, displayed alternating expansive movement (Figure III), or axial compression (Figure IV, and Figure VI), whereas pipes positioned approximately tangential to the epicenter “around the corner”, showed lateral shear effects. (Figure VII and Figure VIII)

Figure VII – Shear effects with ductile response, in RRJ PVC-U of late 1970's age, Christchurch, 2010

EW, VC, RRRC	Localised fracture and separation of bell and pipe barrel.	Gisborne Palmerston Nth Dannevirke Christchurch
PVC	Ductile distortion of pipe and joint, no leaking. (Figure VII and Figure XI)	Gisborne Kaiapoi Christchurch
CI	Fracture of pipe barrel at flange connections.	Christchurch
DI	Localised distortion/disorientation of coupled barrel sections with DI coupling fractures, (in an aerial pipe bridge application), movement beyond compressive capacity of material.	Christchurch
CLS	CLS pressure pipe systems: Localized “telescoping” of joints, tearing and “unraveling” of the spiral weld in the pipe barrel from movement beyond compressive capacity of material.	Christchurch Carterton (Eketahuna)
	Slumping or Lateral Spread in Liquefiable ground	
RRRC	Settlement off grade, pipe barrel fracture, joint fracture, lateral separation, separation from structures	Christchurch
PE-100 pipe systems	Tensile separation at electrofusion joints where movement beyond tensile capacity of joint at the fitting. Tensile separation (yield and break) of pipe, used as a liner in rehabilitation of CI watermain, where movement was beyond tensile capacity of pipe barrel.	Christchurch

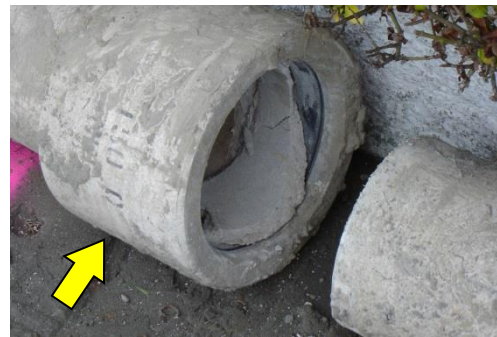
Figure VIII – Shear effects in AC pipe joint, Jollie Street, Kaiapoi, with tangential alignment to the Darfield epicenter, 2010

axial movement did not exceed spigot insertion length), movement beyond tensile capacity of material. (Figure X)	
CI pressure	Localised pull-out of couplers, displacement of screw gland joints and lead wool packed joints.	Christchurch
DI pressure	Joint separation, movement beyond tensile capacity of material.	Christchurch
CLS, GS	Separation where movement beyond tensile capacity of material.	
PE-100	Separation at Electrofusion joints where movement beyond tensile capacity of material.	Christchurch
PE-80, HDPE	Separation of service laterals at restrained mechanical joints where movement beyond tensile capacity of material. Tensile separation of pipe barrel where lateral spread movement beyond tensile capacity of material.	Christchurch
	Lateral Shear movement in Liquefiable ground	
AC	Localised shearing of spigot inside the bell assembly. Pipe barrel often left in reasonable condition, but with the end cracked off and separated. (Figure VIII)	Kaiapoi Christchurch Edgumbe

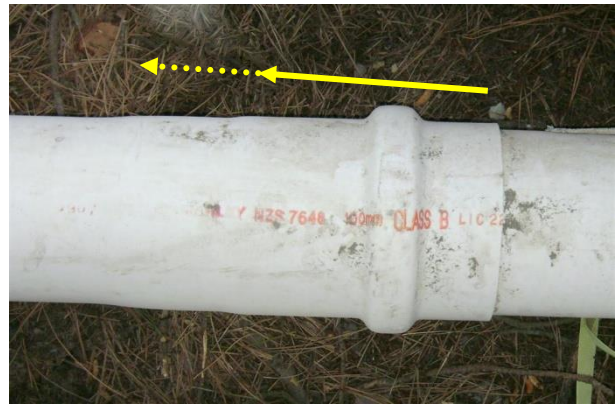
Figure X – Compressed ductile joint movement in PVC-u water main, Christchurch

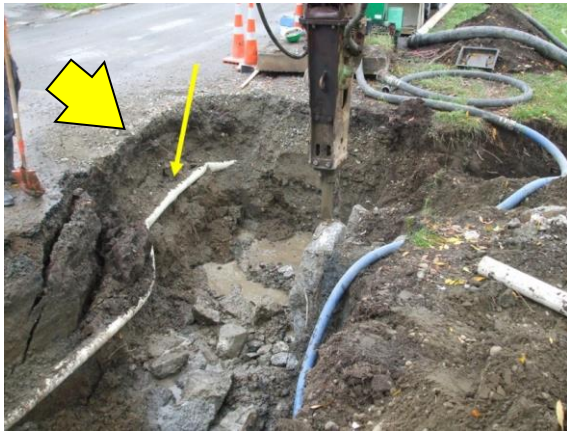
Pipe material behaved in surprising ways. In Christchurch, DN 100 PVC-M pressure pipe, manufactured in 1996, was displaced by sudden lateral spread and squashed behind a large concrete sewer chamber in the Avon river bank (Figure XI). The pipe was found to be still under pressure with reduced flow. The RRJ “Z” joint in the middle of the displaced pipe section which had “pulled” longitudinally about 15 mm, but had permitted the expansive movement, undamaged.

Figure XI - Distorted but still operational, DN100 PVC-M water pipe with joint, Christchurch

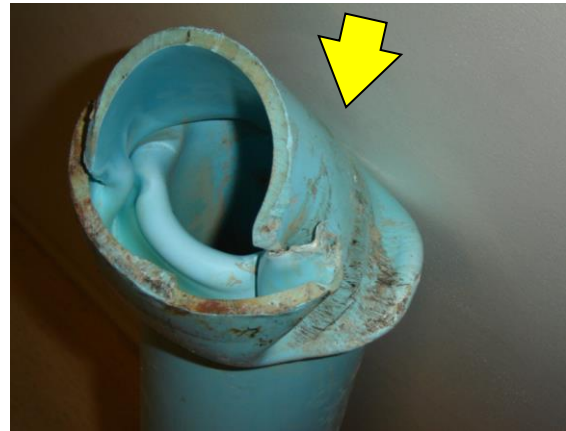
Figure XII - Ductile axial compression folding in PVC-U pipe, Gayhurst Road overbridge

At the Gayhurst Road over bridge crossing the Avon River in Avonside, Christchurch, lateral spread rapidly drove PVC-U watermain axially into the bridge abutment, to cause ductile axial buckling (Figure XII), and disintegration of the CI pipe and joints in the bridge. The crossing connections were quickly repaired with PVC pipe and mechanical couplers, requiring low operator skill, and no electricity to install.
