**RESEARCH PAPER
PVC SEISMIC APPLICATIONS**

**PIPELINE PERFORMANCE EXPERIENCES
DURING SEISMIC EVENTS IN NEW
ZEALAND,
1987 TO 2015**

**Frank W. O'Callaghan, Iplex Pipelines NZ Ltd,
New Zealand**

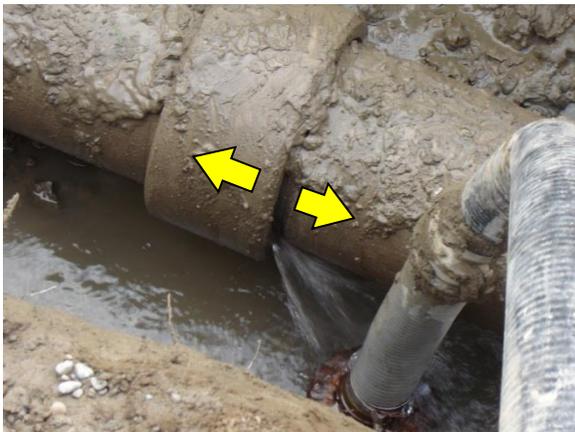
Figure III - Tension effects in AC pipe joint, Sewell Street Kaiapoi, axially aligned with the Darfield epicenter, 2010

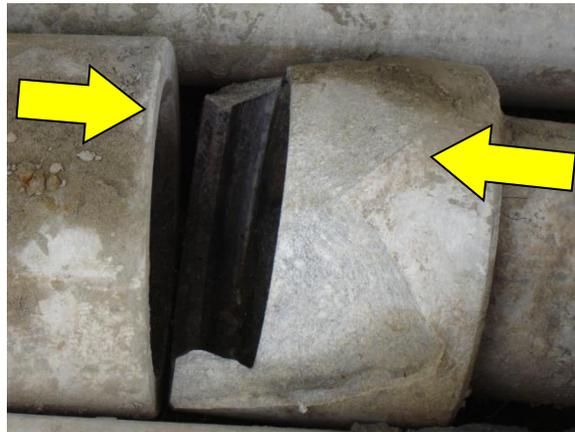
Figure IV - Compression effects in AC pipe joint, Sewell Street, Kaiapoi, axially aligned with the Darfield epicenter, 2010

Pipe/joint type	Compressive Phase movement in Liquefiable ground	Location/ Seismic Event
AC pressure and sewer	Localised 45 deg compression fracture of rubber ring coupling joints and crushed pipe spigots. (Figure IV and Figure VI)	Edgecumbe Christchurch Kaiapoi
EW sewer	Disintegration of whole pipe into random shards, or localised brittle ring fracture of mortar sealed bell and spigot joints.	Edgecumbe Christchurch Kaiapoi
VC sewer	Disintegration of whole pipe into random shards localised brittle fracture of rubber ring bell and spigot joints.	Christchurch Kaiapoi
RRRC sewer	Localised “telescoped” brittle fracture of rubber ring bell and spigot joints.	Christchurch Kaiapoi
PVC pressure and sewer	Localised ductile pipe barrel section folding/buckling. Localised “telescoping” of joints (Figure X), (caused by the pipe spigot being driven through the socket bell, and beyond into the pipe bore itself). Ductile fracture of sewer service lateral junctions, ductile tearing at socket joints,	Christchurch Kaiapoi

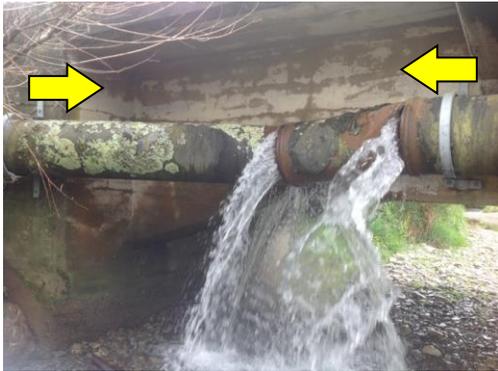
Figure V - Compression distortion and separation of RRJ joints in CLS watermain, 2014

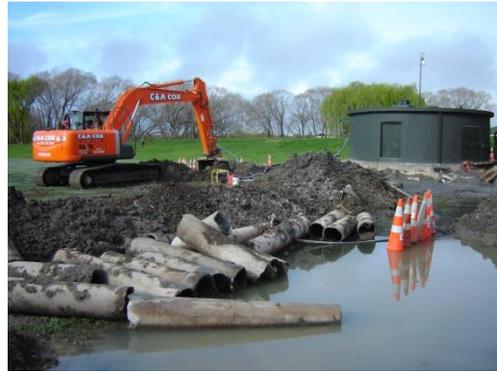
Figure VI – Compression fractures of pipe ends and joints in AC sewer rising main, Charles St, Kaiapoi, axially aligned with the Darfield epicentre, 2010 (Replaced with Biaxially Orientated PVC (PVC-O)

Biaxially orientated PVC (PVC-O) pressure pipe installed in 2010 to replace the destroyed AC sewer rising main at Charles St in Kaiapoi, (Figure VI) remained undamaged, during the Christchurch and Lyttelton events of 2011 and all subsequent aftershocks.

Biaxially orientated PVC (PVC-O) pressure pipe installed in 2010 to replace the destroyed AC sewer rising main at Charles St in Kaiapoi, (Figure VI) remained undamaged, during the Christchurch and Lyttelton events of 2011 and subsequent aftershocks. No seismic failures were reported from the relatively limited PE gas pipe network in Christchurch. PVC and PE pipelines laid in late 2011 between the February 2011 and December 2011 events had no damage reported. However, like all pipe materials observed, the consistent conclusion from observation is that PVC and PE have their mechanical limits and when those limits are exceeded, should be expected to fail or require substantial repair, similar to other pipe materials. PVC-U gravity sewer pipes and fittings are currently widely used in Christchurch City for new residential subdivision developments, and network rebuild. VC and EW pipes are now not used in the Christchurch area, including for industrial lines where PVC-u has been adopted. In the liquefiable east-central and eastern zones of Christchurch, where the weakened ground cannot reliably support thrust blocks, or even open trenches, fusion joined PE is the predominant replacement pressure watermain pipe material used. In other non-liquefiable areas of western, northern and southern Christchurch City, conventional spigot /socket RRJ PVC is widely used for open cut installation, as the work footprint advances beyond repairs/reinstatement and into “green fields” works for new residential subdivision and commercial developments. In neighboring Waimakariri District and Selwyn District, also affected by the Canterbury earthquakes, PVC-U pressure pipes are approved for new and replacement open cut water mains in non-liquefiable zones, with PE-100 the predominant material for pressure sewers, and trenchless drilled installation. In other South Island Council regions, south-west, west and North-east of the Canterbury/Christchurch zone, and exposed to seismic risk from the main Alpine fault itself, pipes in PVC-O, PVC-U, PVC-M and PE are widely accepted and used. Restrained joint PVC-U and Fusible PVCTM have also been used for trenchless replacement of EW Gravity Sewers.

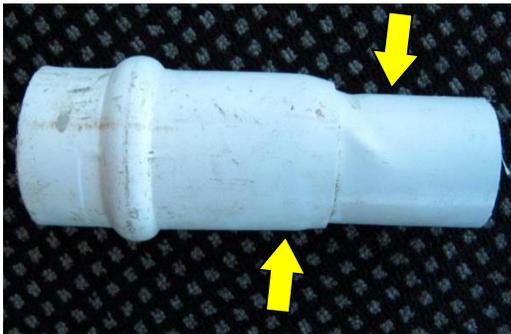
Figure VII – Shear effects with ductile response, in RRJ PVC-U of late 1970's age, Christchurch, 2010

EW, VC, RRRC	Localised fracture and separation of bell and pipe barrel.	Gisborne Palmerston Nth Dannevirke Christchurch
PVC	Ductile distortion of pipe and joint, no leaking. (Figure VII and Figure XI)	Gisborne Kaiapoi Christchurch
CI	Fracture of pipe barrel at flange connections.	Christchurch
DI	Localised distortion/disorientation of coupled barrel sections with DI coupling fractures, (in an aerial pipe bridge application), movement beyond compressive capacity of material.	Christchurch
CLS	CLS pressure pipe systems: Localized “telescoping” of joints, tearing and “unraveling” of the spiral weld in the pipe barrel from movement beyond compressive capacity of material.	Christchurch Carterton (Eketahuna)
	Slumping or Lateral Spread in Liquefiable ground	
RRRC	Settlement off grade, pipe barrel fracture, joint fracture, lateral separation, separation from structures	Christchurch
PE-100 pipe systems	Tensile separation at electrofusion joints where movement beyond tensile capacity of joint at the fitting. Tensile separation (yield and break) of pipe, used as a liner in rehabilitation of CI watermain, where movement was beyond tensile capacity of pipe barrel.	Christchurch

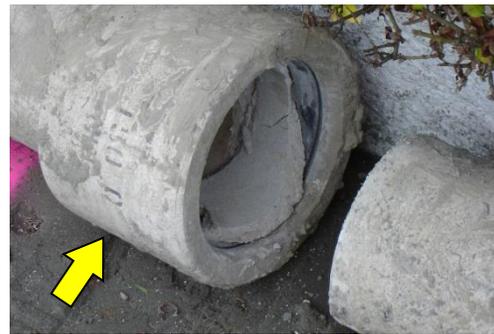
Figure VIII – Shear effects in AC pipe joint, Jollie Street, Kaiapoi, with tangential alignment to the Darfield epicenter, 2010

axial movement did not exceed spigot insertion length), movement beyond tensile capacity of material. (Figure X)	
CI pressure	Localised pull-out of couplers, displacement of screw gland joints and lead wool packed joints.	Christchurch
DI pressure	Joint separation, movement beyond tensile capacity of material.	Christchurch
CLS, GS	Separation where movement beyond tensile capacity of material.	
PE-100	Separation at Electrofusion joints where movement beyond tensile capacity of material.	Christchurch
PE-80, HDPE	Separation of service laterals at restrained mechanical joints where movement beyond tensile capacity of material. Tensile separation of pipe barrel where lateral spread movement beyond tensile capacity of material.	Christchurch
	Lateral Shear movement in Liquefiable ground	
AC	Localised shearing of spigot inside the bell assembly. Pipe barrel often left in reasonable condition, but with the end cracked off and separated. (Figure VIII)	Kaiapoi Christchurch Edgumbe

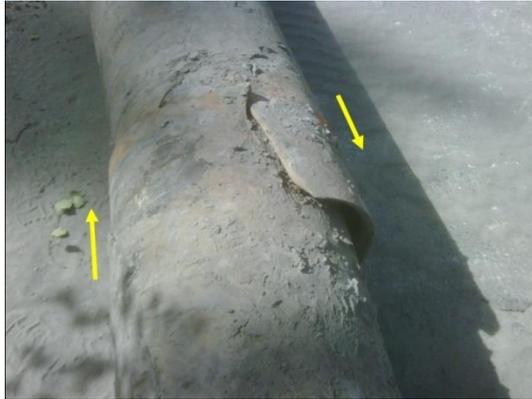
Figure IX - Compressed joint movement in CLS water main, Christchurch

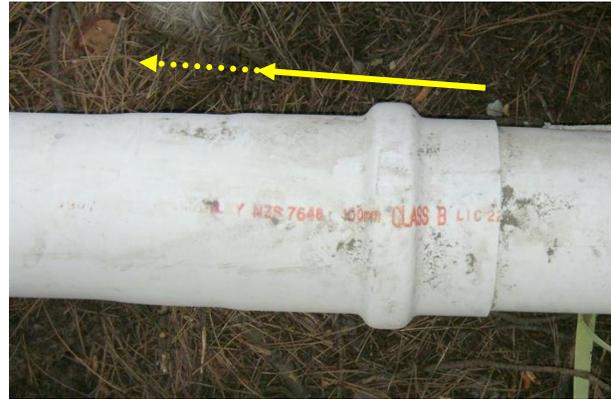
Figure X – Compressed ductile joint movement in PVC-u water main, Christchurch

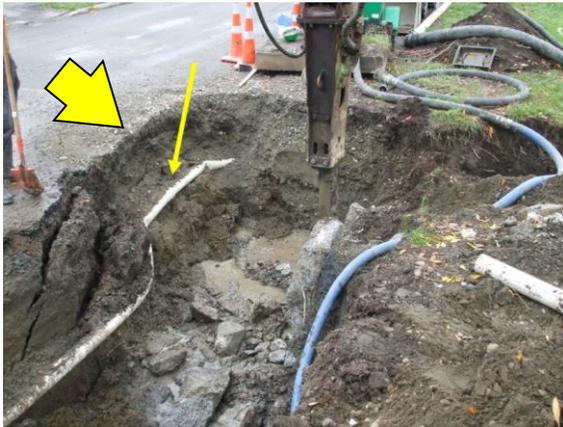
Pipe material behaved in surprising ways. In Christchurch, DN 100 PVC-M pressure pipe, manufactured in 1996, was displaced by sudden lateral spread and squashed behind a large concrete sewer chamber in the Avon river bank (Figure XI). The pipe was found to be still under pressure with reduced flow. The RRJ “Z” joint in the middle of the displaced pipe section which had “pulled” longitudinally about 15 mm, but had permitted the expansive movement, undamaged.

Figure XI - Distorted but still operational, DN100 PVC-M water pipe with joint, Christchurch

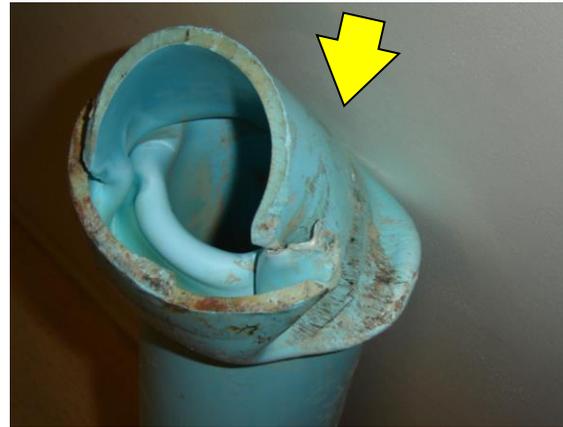
Figure XII - Ductile axial compression folding in PVC-U pipe, Gayhurst Road overbridge

At the Gayhurst Road over bridge crossing the Avon River in Avonside, Christchurch, lateral spread rapidly drove PVC-U watermain axially into the bridge abutment, to cause ductile axial buckling (Figure XII), and disintegration of the CI pipe and joints in the bridge. The crossing connections were quickly repaired with PVC pipe and mechanical couplers, requiring low operator skill, and no electricity to install.
