# *Drilling Fluids Return Pipeline, Whenuapai Sewer Syphon, Auckland.*

## **Project Overview**

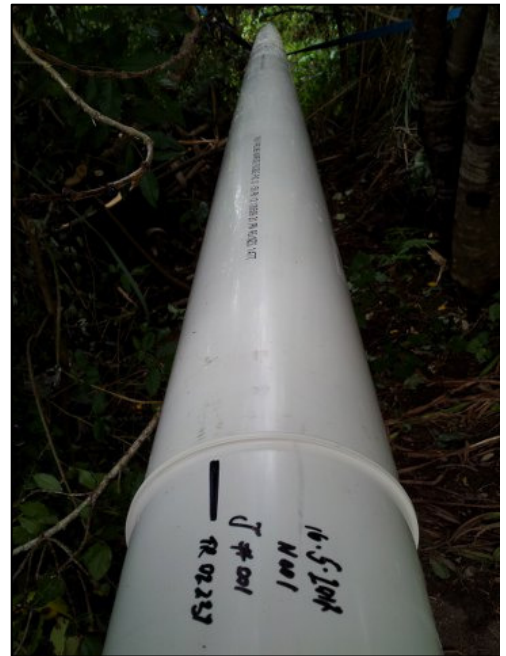
*Low profile fusion bead joining two pipe ends.*

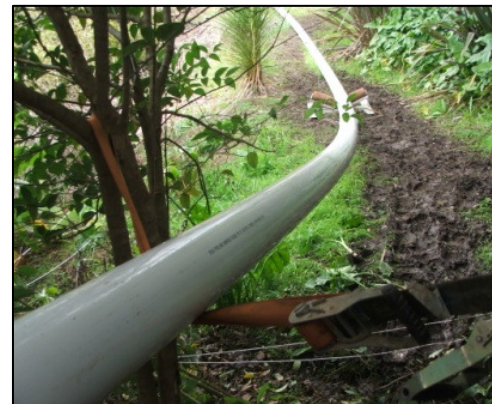
*Typical radius of curvature during construction.*

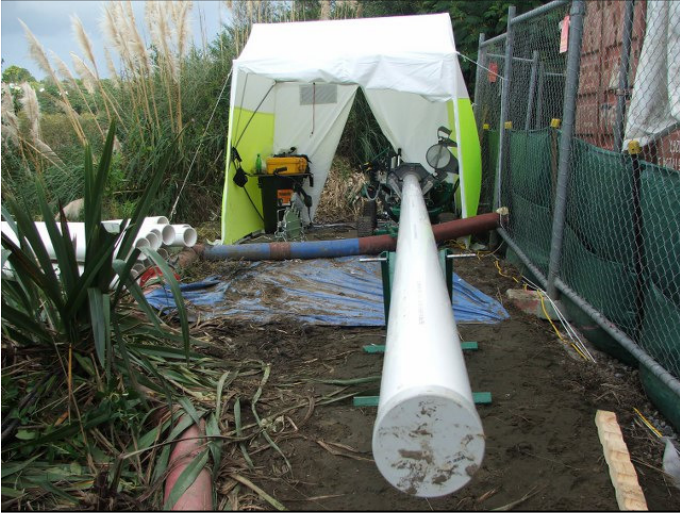
*Fusion jointing staging platform.*

Novafuse™ was manufactured in 7m lengths for this project as the Fusion staging area had extremely limited space. The pipes were hand lifted onto the fusion platform where 43 fusion joints were completed using a McElroy 2-8 wheeled butt fusion machine. The McElroy DataLogger™ provided the contractor with electronic logging of the fusion conditions.

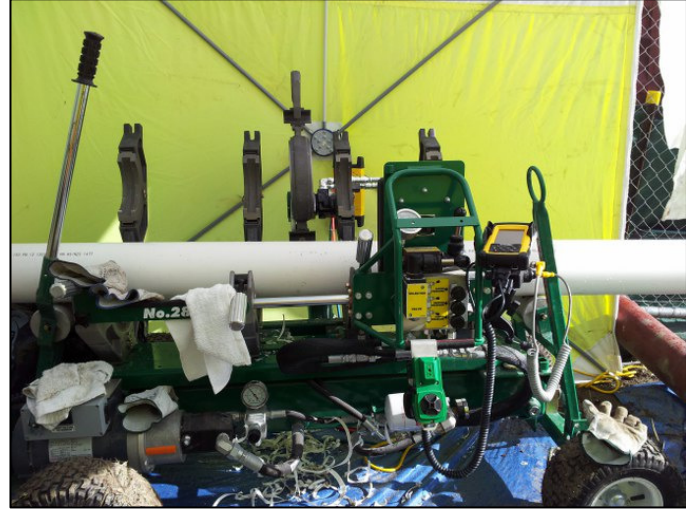
*McElroy 2-8 Wheeled Fusion machine complete with Trimble Recon hand held DataLogger™*

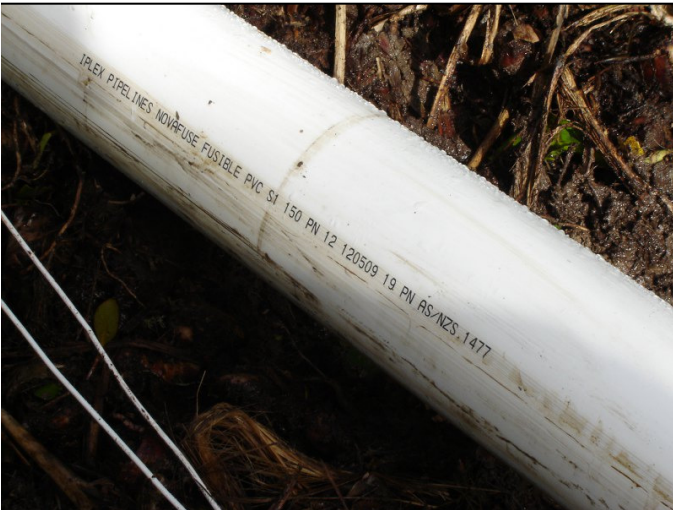
*Novafuse print and fusion joint in the mangrove salt marsh.*

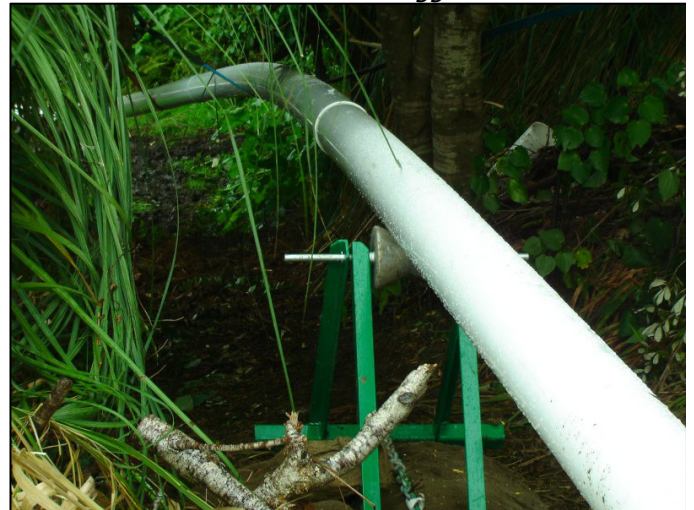
*Typical radius of curvature during construction.*

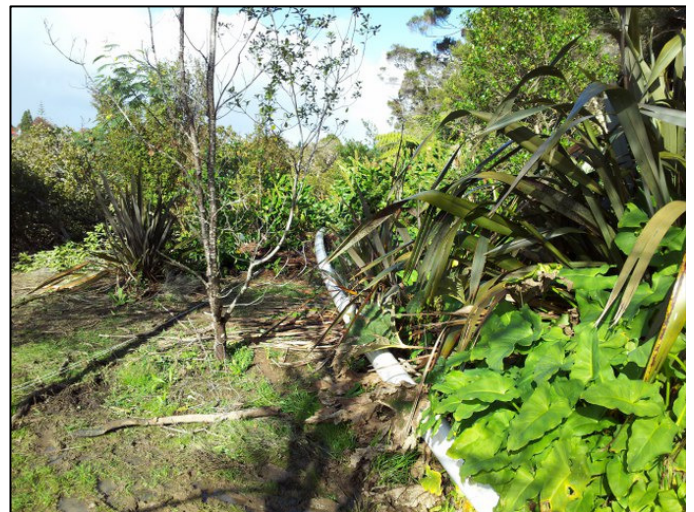
*Fusible PVC™ Pipe String twisting its way through the Mangrove salt marsh*

Initially, the pipeline was pulled out into the mangrove swamp by hand as the Novafuse™ option was much lighter in weight when compared to traditional Polyethylene pipe. Eventually a tracked bobcat pulled the pipe into the mangrove swamp to its final position.
