THE HAMNAK PIPELINE – NEW ZEALAND’S LONGEST PVC-O WATER TRANSMISSION PIPELINE

A. J. Roy, Iplex Pipelines NZ Ltd, New Zealand

The Hamnak Pipeline Project (formally the H2Our Health project), in New Zealand’s Waitaki District, was successfully undertaken in 2017-2018 to connect Oamaru’s water reticulation with the Herbert/Waianakarua and Hampden/Moeraki water supplies. The objective was to install a new pipeline that would deliver drinking water to over 1300 permanent residents of these communities and was fully compliant with Drinking-water Standards for New Zealand (DWSNZ).

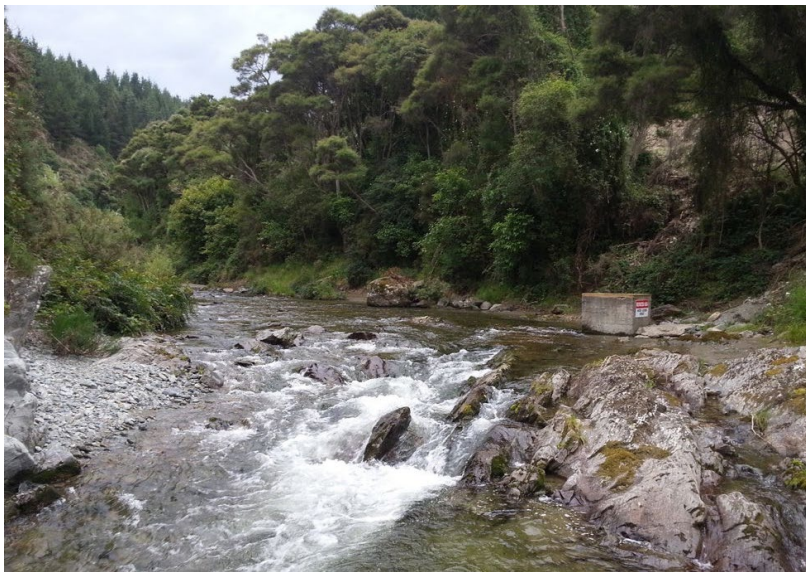
*Photograph 1: Former Herbert-Waianakarua water supply intake (Normal conditions)
(Image courtesy – Waitaki District Council)*

- Vulnerable to drought & flood events resulting in frequent supply restrictions (refer to Photographs 1 & 2).
- Undersized for future population and business growth.
- Maintained and governed by local water scheme operators.
- Reaching end of life and susceptible to failures.

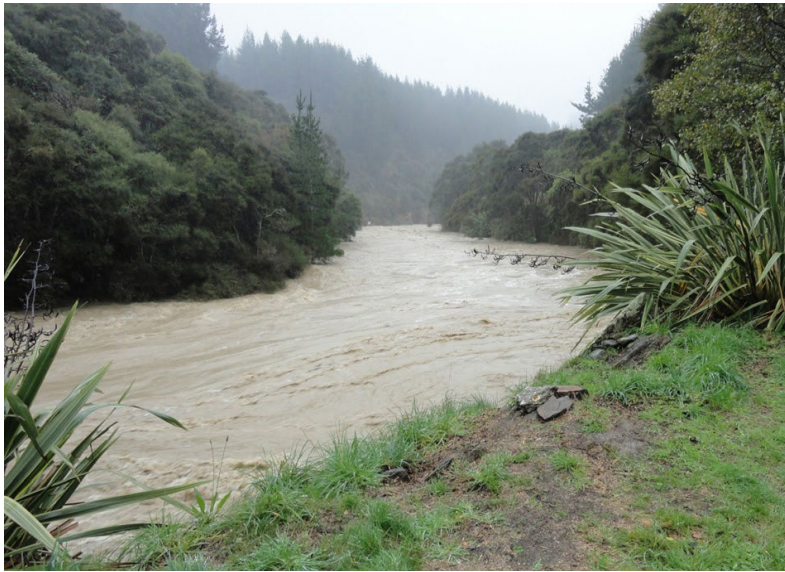
*Photograph 2: Former Herbert-Waianakarua water supply intake (Flood Conditions)
(Image courtesy – Waitaki District Council)*

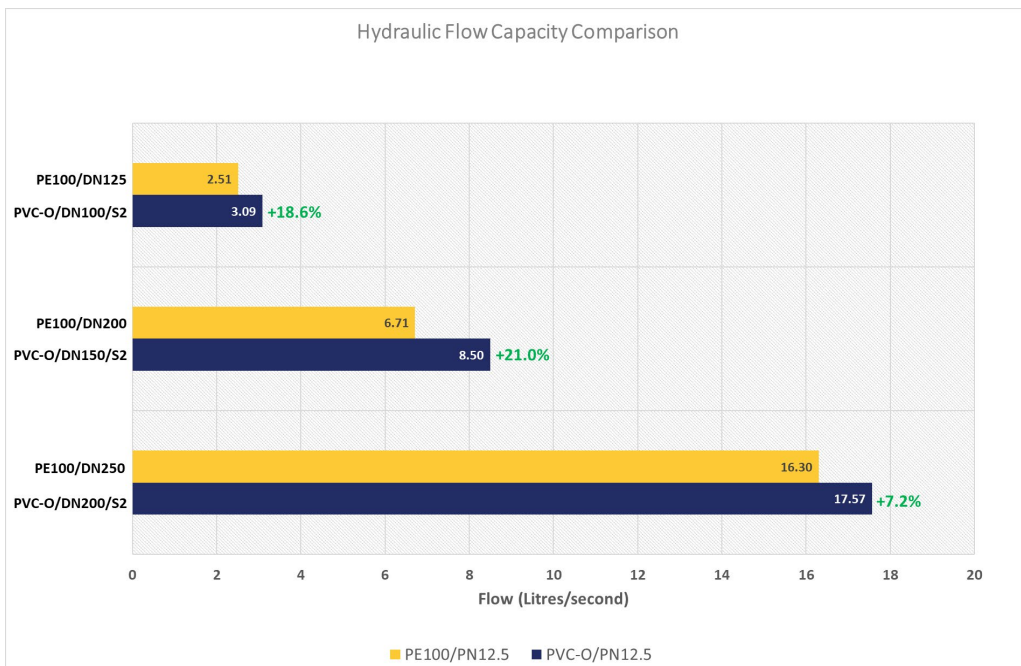
A simple comparison of hydraulic flow capacities carried out based on the Lamont S3 formula (O’Callaghan, 1983) using a Hydraulic Gradient (i) of 0.001 and assuming full bore flow illustrated the advantages of PVC-O as an alternative material over a similar nominal diameter of PE100 pressure pipe. This is shown on Figure 3.

Figure 3: Hydraulic flow capacity comparison for given material choices

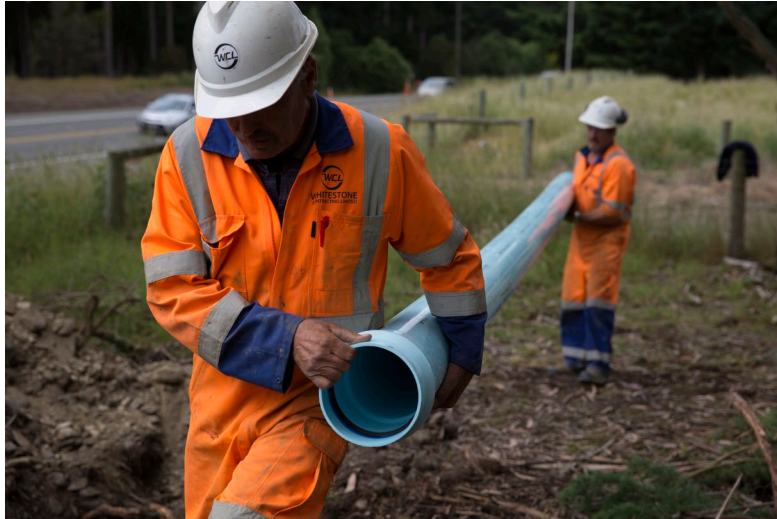
*Photograph 4: Site handling a 6.5 m length of DN200 Series 2 PVC-O
(Image courtesy – Iplex Pipelines NZ Limited)*

The Contractor had two (2) pipelaying crews operating to ensure that pipelaying continued at pace (up to 200 metres/day dependent on conditions). The open-cut methodology, combined with light weight pipe, enabled quick installation and reinstatement of excavations as the work face advanced through. Typical examples of pipelaying activities with PVC-O pipe are shown in Photographs 4 to 6.

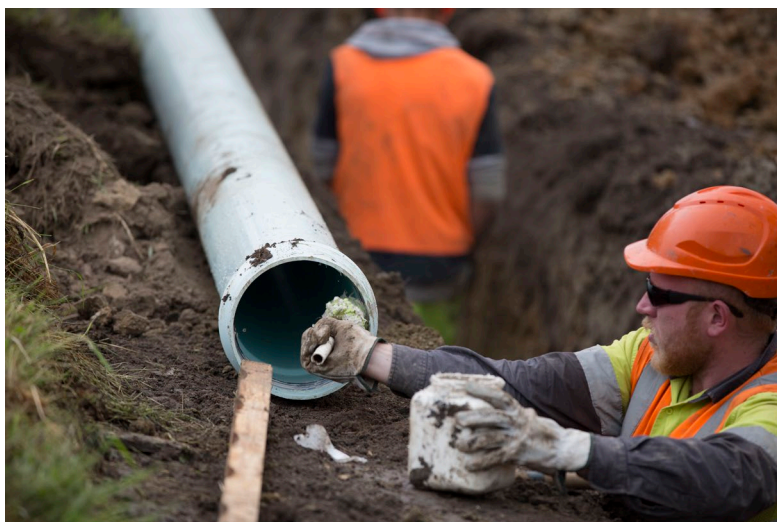
*Photograph 5: Application of bactericidal pipe jointing lubricant to the locked-in-place
seal ring
(Image courtesy – Iplex Pipelines NZ Limited)*

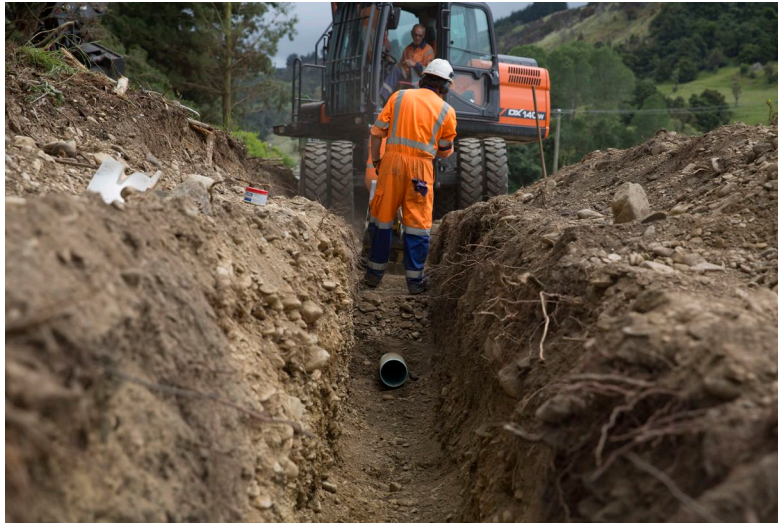
*Photograph 6: Compaction of embedment zone above pipe
(Image courtesy – Iplex Pipelines NZ Limited)*

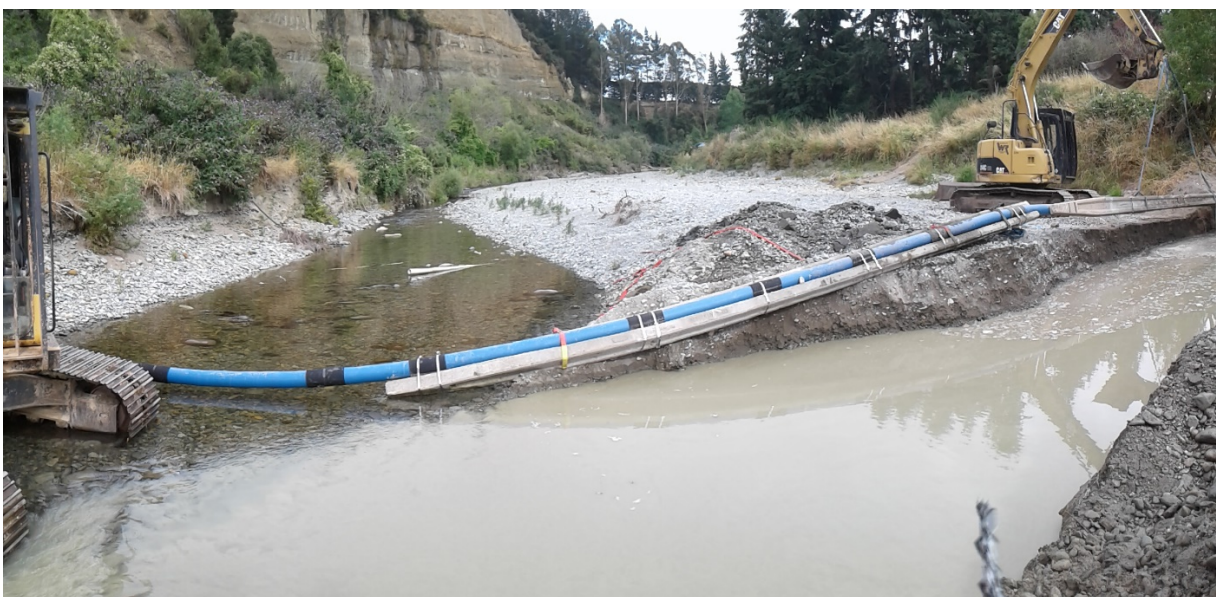
In the case of the Waianakarua River crossing where open excavation was used to install the pipeline, the Contractor gained engineering approval to install the PE100 DN180 pipeline section using an innovative methodology. Eight (8) repurposed concrete power poles were strapped onto the PE100 pipe with rubber sheathing to protect the pipeline as shown on Photograph 7. This prevented the pipeline from floating, during placement in the excavation. The challenging site conditions included both mobile alluvial river bed materials within a sandstone dish – and a continuously flowing river.

*Photograph 7: Waianakarua River Crossing utilising concrete poles for anchorage.
(Image courtesy – Waitaki District Council & Whitestone Contracting)*

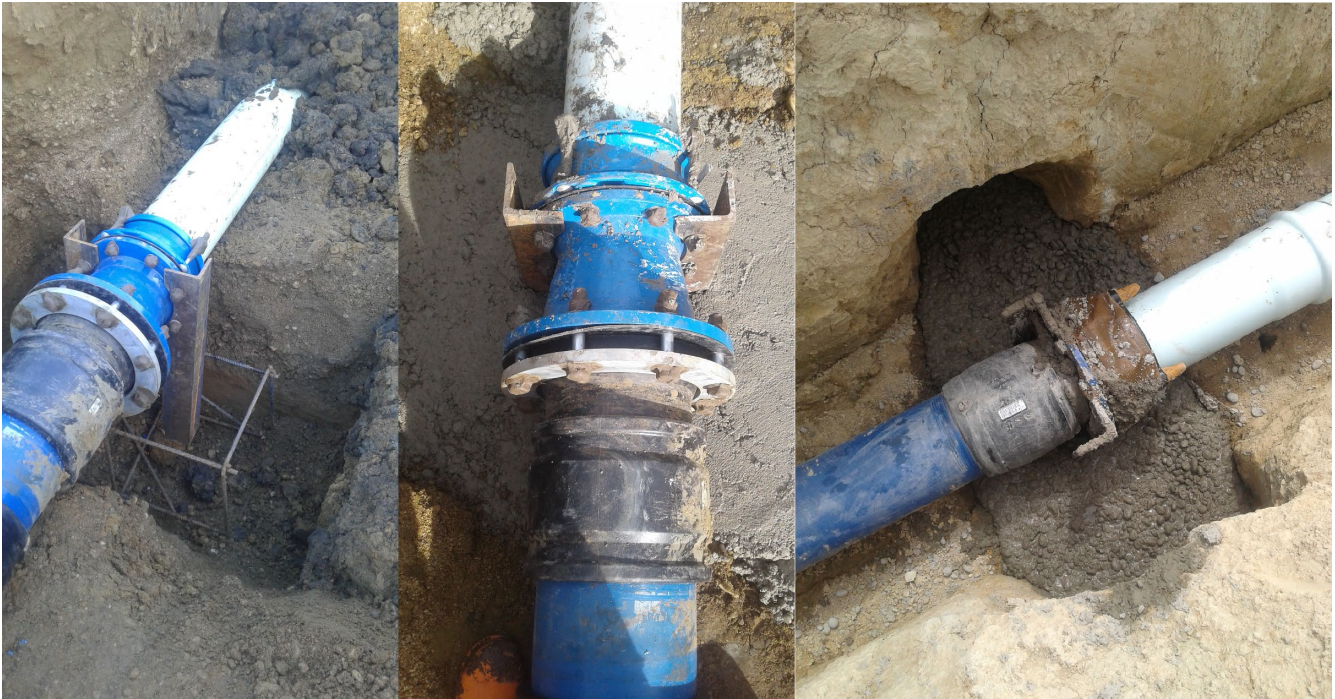
Special accommodations were made for PE to PVC transition connections – wherein the Ductile Iron flange assembly on the PVC side was secured onto vertical brackets permanently set into a large concrete anchor-block under the assembly. The anchor block extended a minimum of 300 mm past the trench walls on both sides supported against undisturbed ground. This provided post-installation surety that the assembly was well restrained and protected against lateral movement. Examples of how this was achieved in the field are shown in Photographs 8 to 10.

Photographs 8, 9 & 10: PE to PVC Flange transition joint assemblies with associated restraint brackets.
