CASE STUDY

IPLEX RESTRAIN® Kingsland DN300 Stormwater Rehabilitation

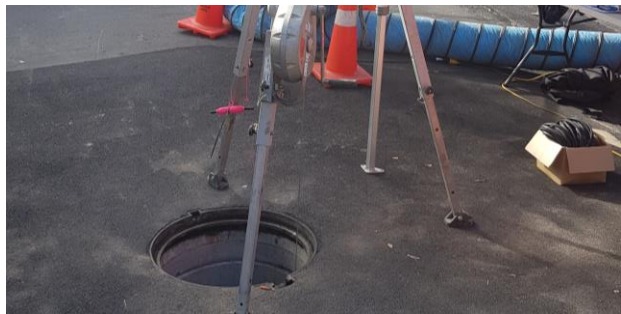
Humes Pipeline Systems (Part of Fletcher Concrete), partnered with CDS New Zealand on the project & manufactured the concrete structures. CDS NZ started by installing a new 4.2m deep, 1.8m wide flange base manhole. This would allow for safe access and easy installation of Iplex Restrain® pipe.

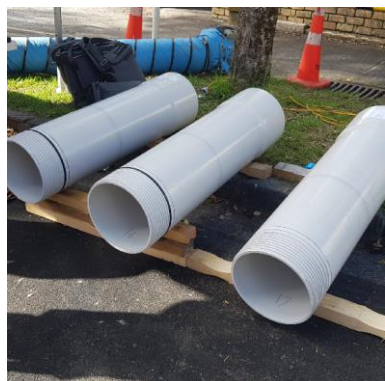
Iplex Restrain DN300 PN16 Pipes

Iplex Restrain® DN300 PN16 in 1.0m lengths was specified for the project. This allowed for easy handling down the manhole to the pipeline. A pipe reaming head was attached to the first pipe and then drawn through by a drilling rig located at the next street over.

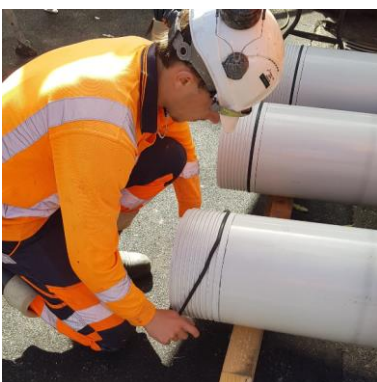
Fitting the Seal Ring

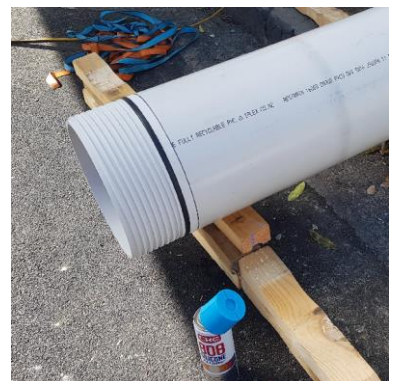
Approved Silicon Spray Lubricant Applied
